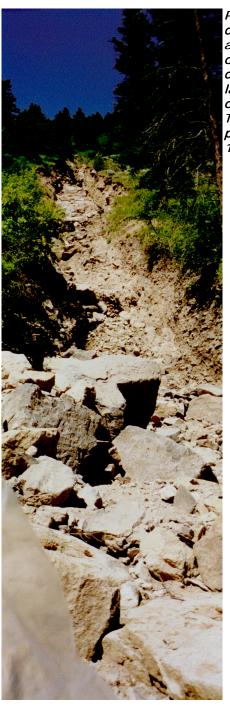
Photograph A- 41. A large debris flow between Badger and Bitch Creeks on the left canyon wall in 1997. This debris flow is evidence that landslides are a naturally occurring process in the Teton River Canyon. USBR photograph by Tim Randle, 1997.

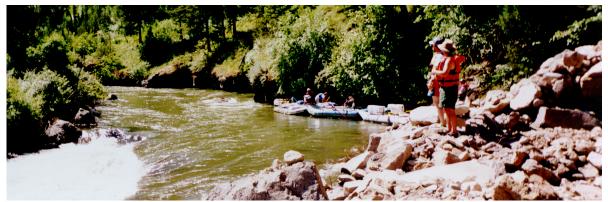
Photograph A- 42. This photograph shows the debris and rapid resulting from the debris flow shown in photograph A- 41. USBR photograph by Tim Randle, 1998.

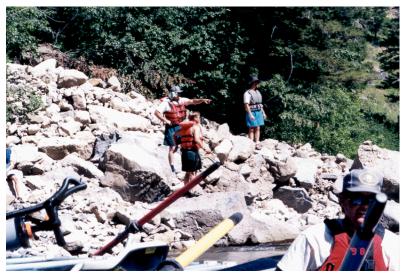
Photograph A- 43. Closeup view of the debris flow shown in photographs A- 41 and A- 42. Note the size of debris compared to people standing on rocks. USBR photograph by A.C. Lockhart, July 19, 1998.

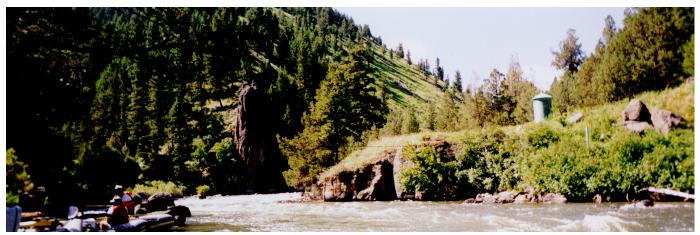
Photograph A- 44. USGS gage site (Station 13054200) between Badger and Bitch Creeks. USBR photograph by Jennifer Bountry, 1998.

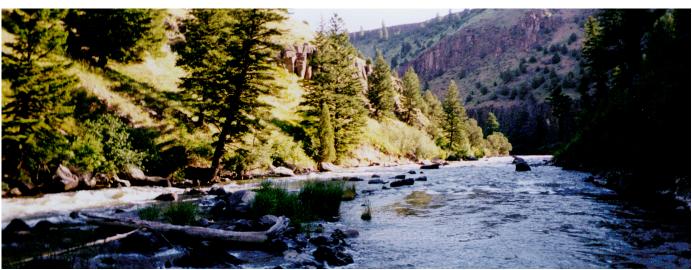
Photograph A- 45. Looking downstream from Felt Dam Powerhouse, located about 19 miles upstream of Teton Dam. USBR photograph by Jennifer Bountry, 1998.

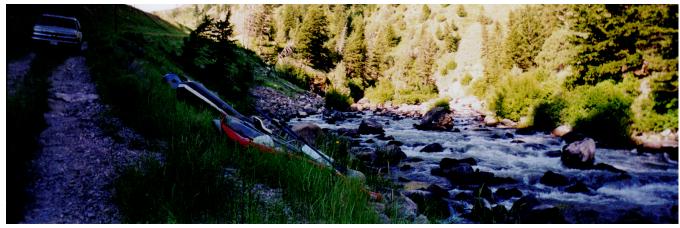
Photograph A- 46. Looking upstream from Felt Dam Powerhouse. This is the upstream end of the study reach. USBR photograph by Jennifer Bountry, 1998.
